# Manhole Inspection Summary

Manhole # S31YY1007MH

**Location** Address: **121 UPNOR RD** Cross Street: **SAINT ALBANS WAY**

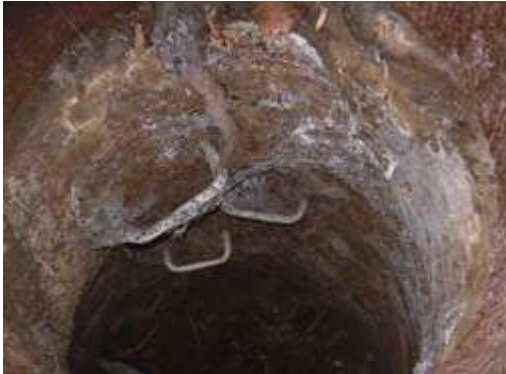
Defect

Bench debris.

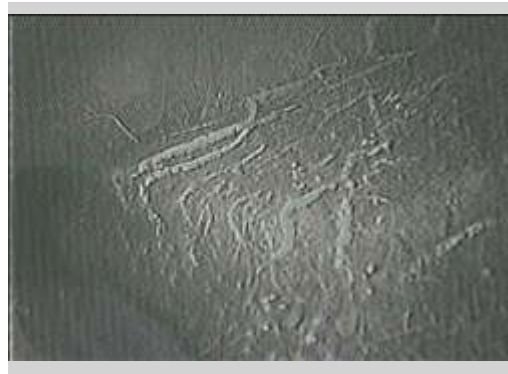
Defect

Frame offset. Adjustment, Corbel and Barrel root intrusion and infiltration - other side.

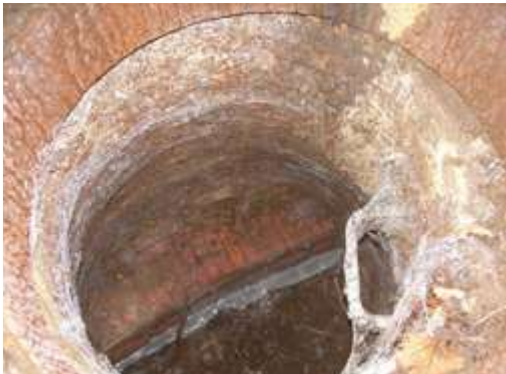
Defect

Barrel, Bench and Channel root intrusion and debris.

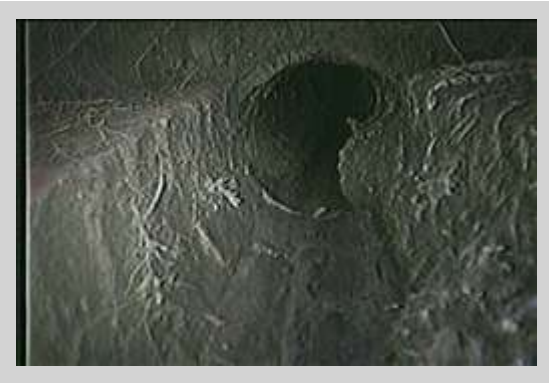
### 8 in. Circular Gravity Sewer Pipe Out @ 12 O'Clock

Bench and Channel root intrusion.

Infiltration: **None** Pipe Seal Cond: **Roots**

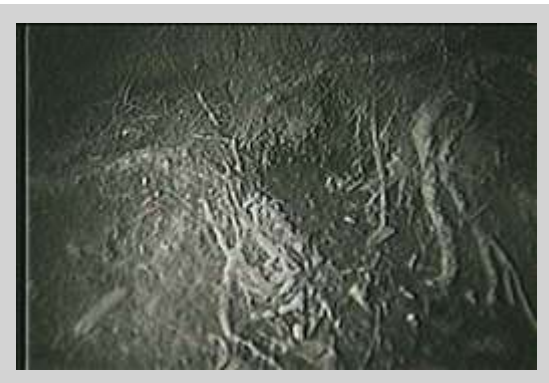
### 6 in. Circular Gravity Sewer Pipe In @ 4 O'Clock

Bench and Channel root intrusion.

Infiltration: **None** Pipe Seal Cond: **Roots**

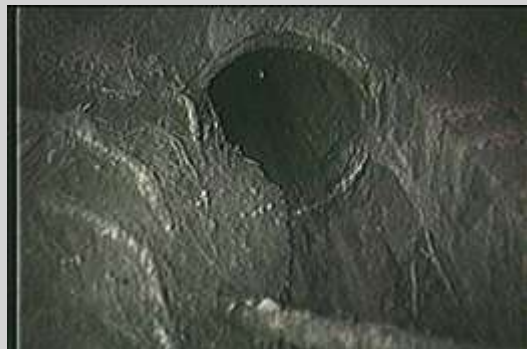
Pipe In @ 6 O'Clock

Bench and Channel root intrusion.

Infiltration: **Evidence**

Pipe Seal Cond: **Roots**
